Roof Investigation Report

124 to 139 Vischer Drive Mountain Village, CO 81435

Daniel J Cupit

Professional Roofing Consultant

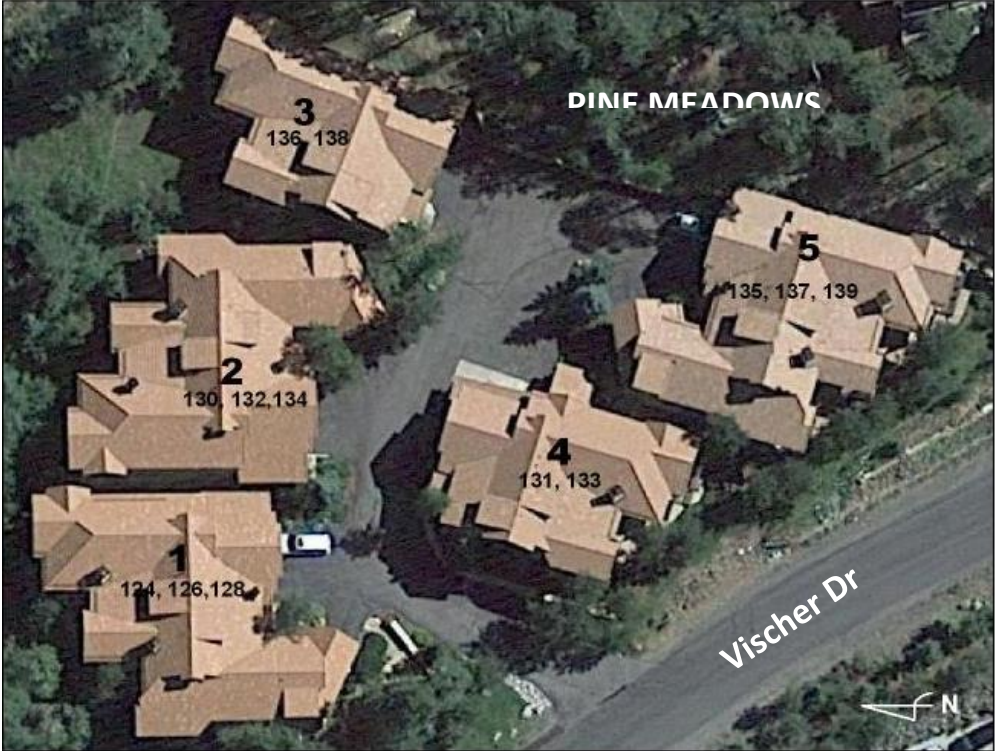
The existing site is located at 124 to 139 Vischer Drive in Mountain Village, Colorado (Telluride) and consists of 5 buildings with a total of 13 units.
